Manhole Inspection Summary

Manhole # S11CC2023MH

Insp Date: **9/27/06 10:09 AM**

Location Address: **5812 GREENSPRING AVE**

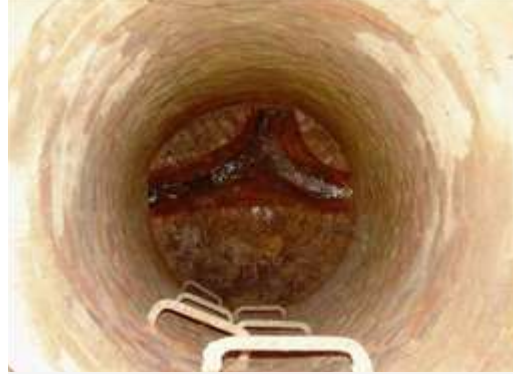
Top View

Evidence of surcharge - Bench debris.

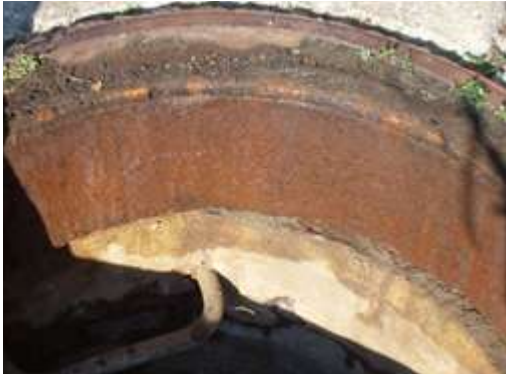
Defect

Frame leaks. Adjustment deterioration and infiltration. Corbel infiltration - other side.

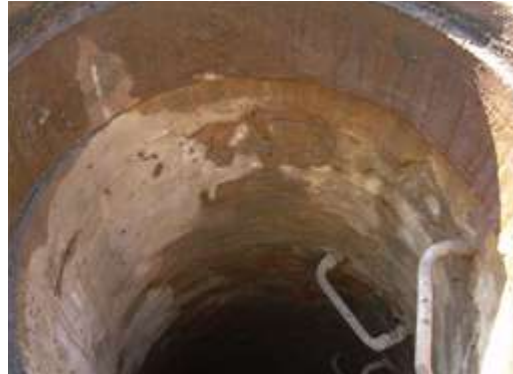
Defect

Frame leaks. Adjustment deterioration and infiltration. Corbel infiltration.

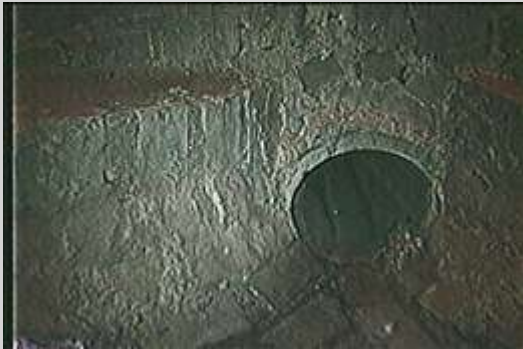
Pipe Out @ 12 O'Clock

Barrel deterioration and infiltration.

Infiltration: **Evidence** Pipe Seal Cond: **Cracked**

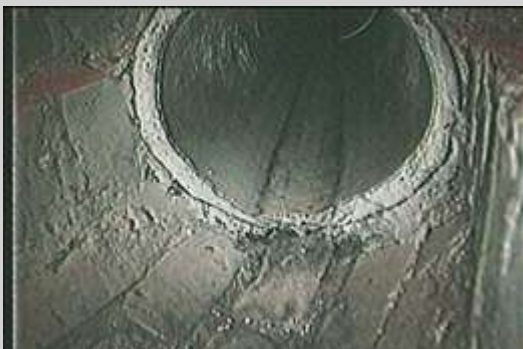
Pipe In @ 3 O'Clock

Infiltration: **Evidence** Pipe Seal Cond: **Unknown**

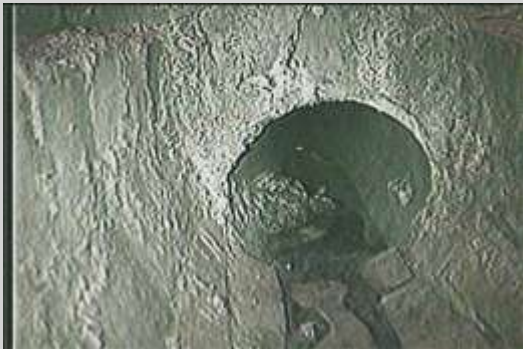
8 in. Circular Gravity Sewer
Pipe In @ 9 O'Clock

Deposits: ☐ None ☒ **Mud** ☐ Sludge ☒ **Debris** ☐ Grease

Silt Depth: **0.5** (in.) Deposits Extent: **Light**

Infiltration: **None** Pipe Seal Cond: **Cracked**
